Manhole Inspection Summary

Manhole # S07EE2025MH

Insp Date: **7/19/06 10:31 AM**

Location Address: **6102 GREENSPRING AVE**

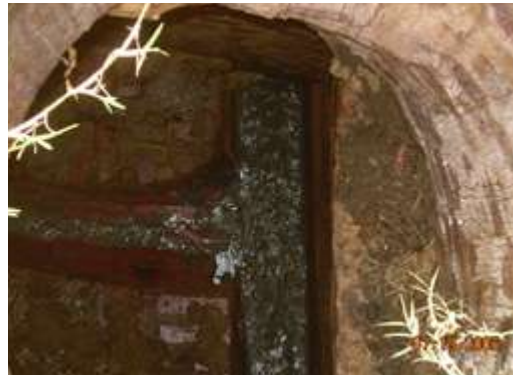
Top View

Infiltration: ☐ None ☒ **Joint** ☐ Cracks ☒ **Mortar** ☐ Roots ☐ Wall

Surcharge ☒ **Evidence Of Surcharge** Depth: **1.5** (ft.) ☐ Active Surcharge Present

Adjustment infiltration. Evidence of surcharge - Bench debris.

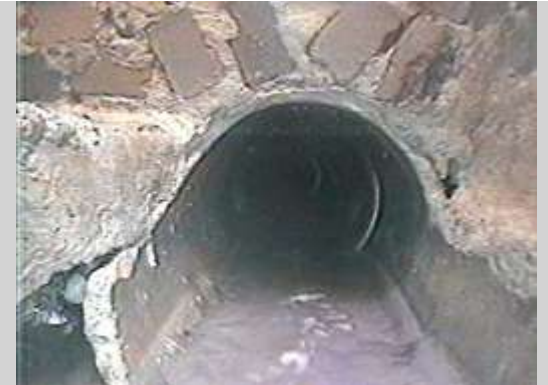
10 in. Circular Gravity Sewer Pipe Out @ 12 O'Clock

Condition: ☐ Sound ☐ Cracked ☐ Root Intrusion ☒ **Deteriorated** ☐ Leaks ☐ Debris

Channel deterioration.

Infiltration: **Evidence** Pipe Seal Cond: **Broken**

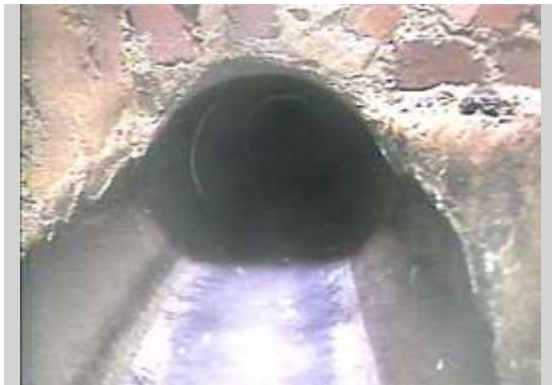
10 in. Circular Gravity Sewer Pipe In @ 6 O'Clock

Infiltration: **Evidence** Pipe Seal Cond: **Unknown**

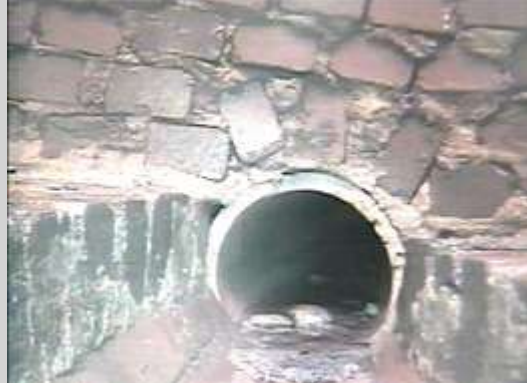
8 in. Circular Gravity Sewer

Condition: ☐ Sound ☐ Cracked ☐ Root Intrusion ☐ Loose Brick ☒ **Deteriorated**

Infiltration: ☐ None ☐ Joint ☐ Cracks ☒ **Mortar** ☐ Roots ☒ **Wall**

Barrel deterioration and infiltration.
